JURISDICTIONAL DETERMINATION REQUEST

Project Name: Chester Technology Park

Reference: Request for Jurisdictional Determination

Chester Technology Park – 163.2 Acres
Chester, Chester County, South Carolina
S&ME Project No. 1614-10-257

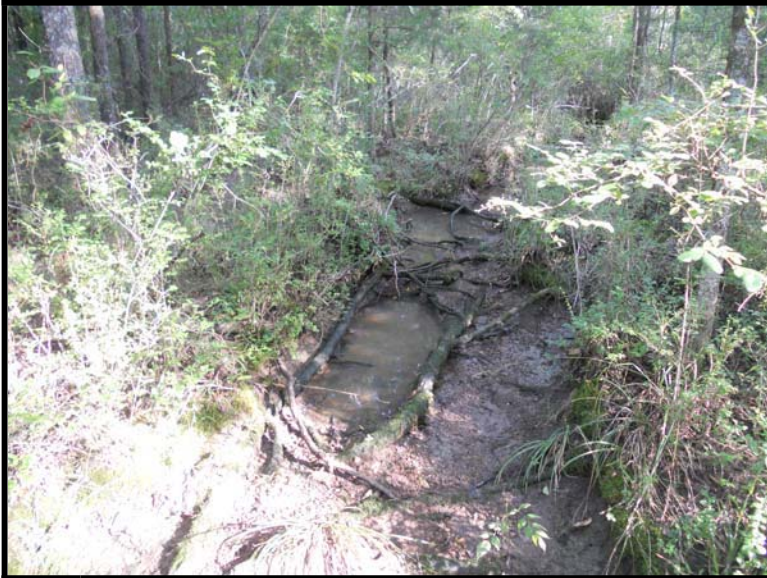
One jurisdictional wetland (Wetland A) was observed on the northern portion of the site. Wetland A abuts Stream 2.

1 Wetland A (forested wetland) with drainage patterns on northern portion of site..

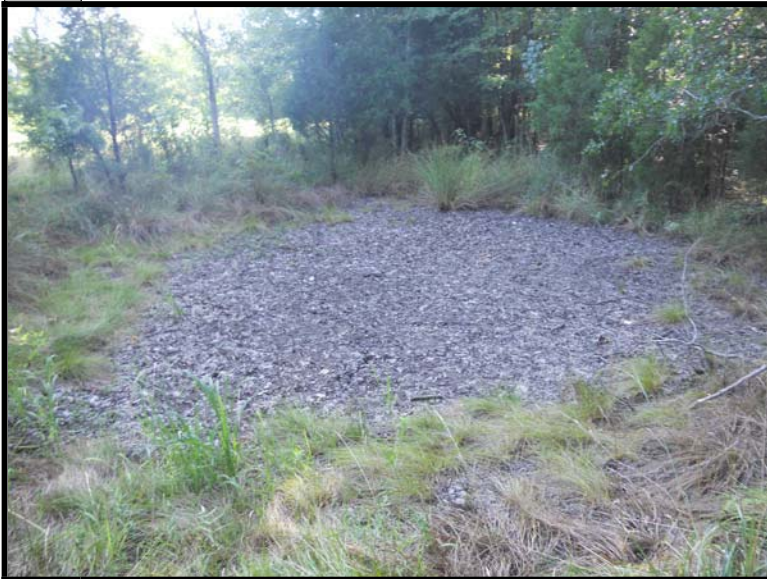
Wetlands B and C were observed on the northern portion of the site. These depressional wetlands appear to be isolated with no hydrologic connections to other jurisdictional waters. An upland-dug pond was also observed on the southeastern portion of the site. The upland-dug pond is fed by Non-RPW 4 as well as overland flow from the surrounding fields during heavy rain events. Mapping from the USGS and the U.S. Department of Agriculture-National Resource Conservation Service (USDA-NRCS) depict a linear, blue-line feature (Non-RPW 5) extending east from the pond indicating a surface connection between these two features. However, our field reconnaissance did not indicate this to be accurate. No riser pipe, culvert, or dam seepage was observed to indicate a surface connection between the upland-dug pond and Non-RPW 5. In the event the upland-dug pond exceeds its capacity, the overflow is directed to an earthen spillway on the southeastern side of earthen dam. The overflow then dissipates in the field southeast of the upland-dug pond. Over 500 feet separate the upland-dug pond from Non-RPW 3 located to the east. Based on these observations, the upland-dug pond appears to be a non-jurisdictional feature.

3 Wetland B (depressional wetland) on northern portion of site.

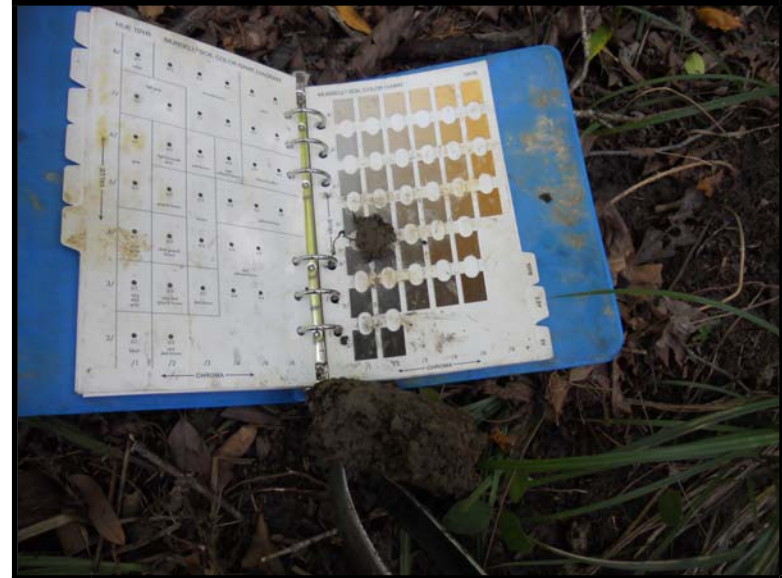
2 Hydric soils (10YR 4/2) in Wetland A.

Map Unit Name:	IdB		Drainage Class:	Mod. Well	
(Series and Phase):	Iredell fsl		Field Observations		
Taxonomy (subgroup):	Typic hapludalfs		Confirm Mapped Type?		
Profile Descriptions:					
Depth	Horizon	Matrix Color	Mottle Color	Mottle Abundance	Texture
1-16"	A	10 YR 4/2			Sandy loam
Hydric Soil Indicators:					
Histosol.....>			Concretions.....>		
Histic epipedon.....>			High organic content in the surface layer of sandy soils.....>		
Sulfidic odor.....>			Organic streaking in sandy soils.....>		
Aquic moisture regime.....>			Listed on local hydric soils list.....>		
Reducing conditions.....>			Listed on national hydric soils list.....>		
Gleyed or low chroma colors.....>			Other (explain)		
Remarks: Hydric soils present

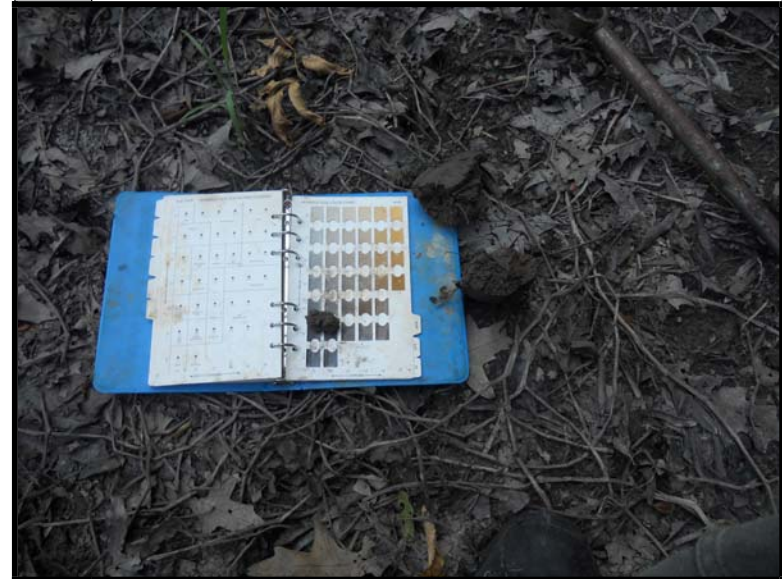
4 Hydric soils (10YR 3/1) in Wetland B.

Map Unit Name:	IdB	Drainage Class:	Mod. Well
(Series and Phase):	Iredell fsl	Field Observations	
Taxonomy (subgroup):	Typic hapludalfs	Confirm Mapped Type?	
Profile Descriptions:			
Depth	Horizon	Matrix Color	Mottle Color
1-16"	A	10 YR 3/1	
Hydric Soil Indicators:			
Histosol.....>		Concretions.....>	
Histic epipedon.....>		High organic content in the surface layer of sandy soils.....>	
Sulfidic odor.....>		Organic streaking in sandy soils.....>	
Aquic moisture regime.....>		Listed on local hydric soils list.....>	
Reducing conditions.....>		Listed on national hydric soils list.....>	
Gleyed or low chroma colors.....>	X	Other (explain)	
Remarks: Hydric soils present

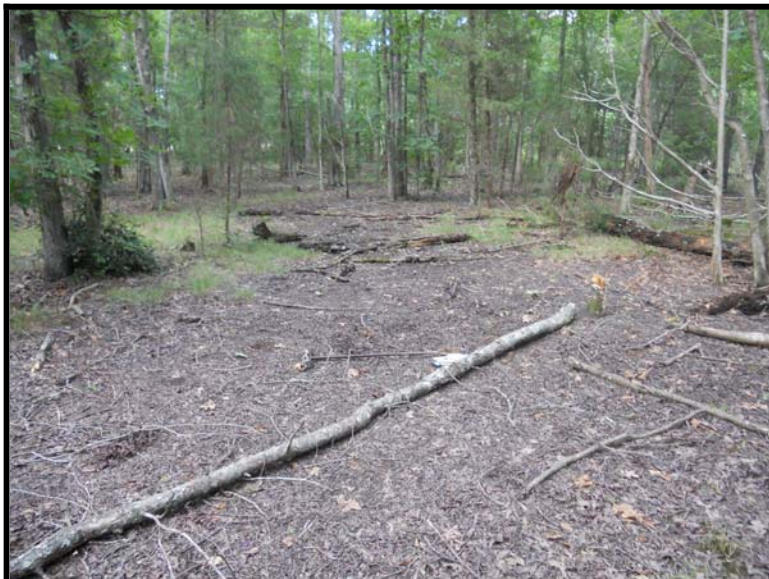
5 Wetland C (depressional wetland) on northern portion of site.

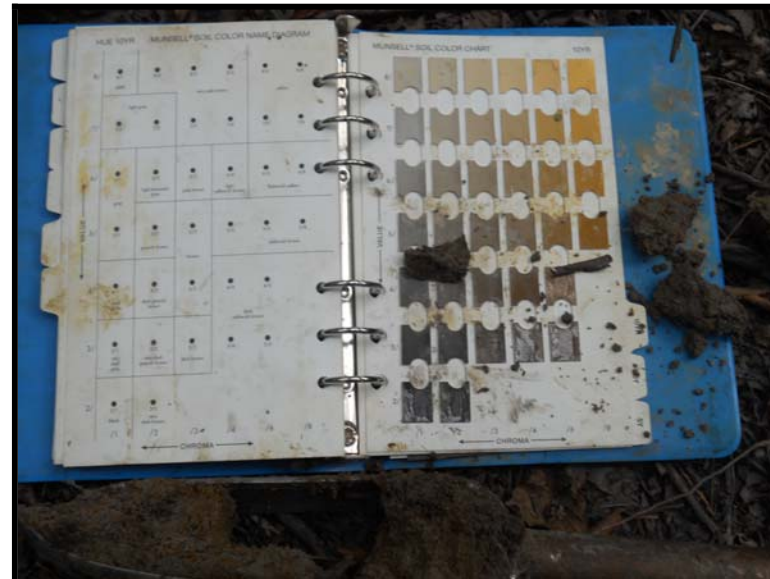
6 Hydric soils (10YR 4/2) in Wetland C.

Map Unit Name:	IdB		Drainage Class:	Mod. Well	
(Series and Phase):	Iredell fsl		Field Observations		
Taxonomy (subgroup):	Typic hapludalfs		Confirm Mapped Type?		
Profile Descriptions:					
Depth	Horizon	Matrix Color	Mottle Color	Mottle Abundance	Texture
1-16"	A	10 YR 4/2			Loamy clay
Hydric Soil Indicators:					
Histosol.....>	X		Concretions.....>		
Histic epipedon.....>			High organic content in the surface layer of sandy soils.....>		
Sulfidic odor.....>			Organic streaking in sandy soils.....>		
Aquic moisture regime.....>			Listed on local hydric soils list.....>		
Reducing conditions.....>			Listed on national hydric soils list.....>		
Gleyed or low chroma colors.....>			Other (explain)		
Remarks: Hydric soils present

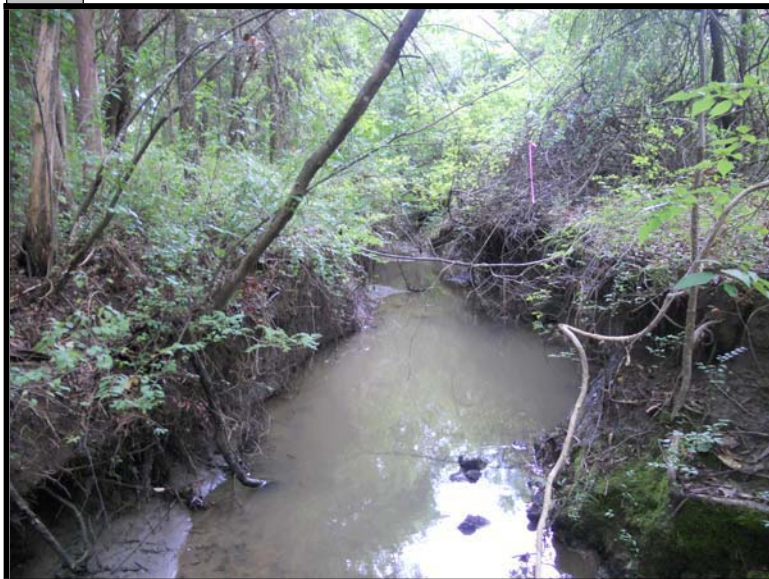
Three jurisdictional linear features (Streams 1-3) were observed on the site. Stream 1 appears to be a Perennial Relatively Permanent Water (P-RPW) flowing east from an impoundment just west of the site. Stream 2 appears to be a Seasonal RPW (S-RPW) flowing north from Wetland A. Stream 3 also appears to be a S-RPW flowing east into an impoundment located just east of the site. Stream 3 is a second-order stream formed by the junction of two Non-RPWs (Non-RPWs 2 and 5).

7 Stream 1 (P-RPW) on northern portion of site.

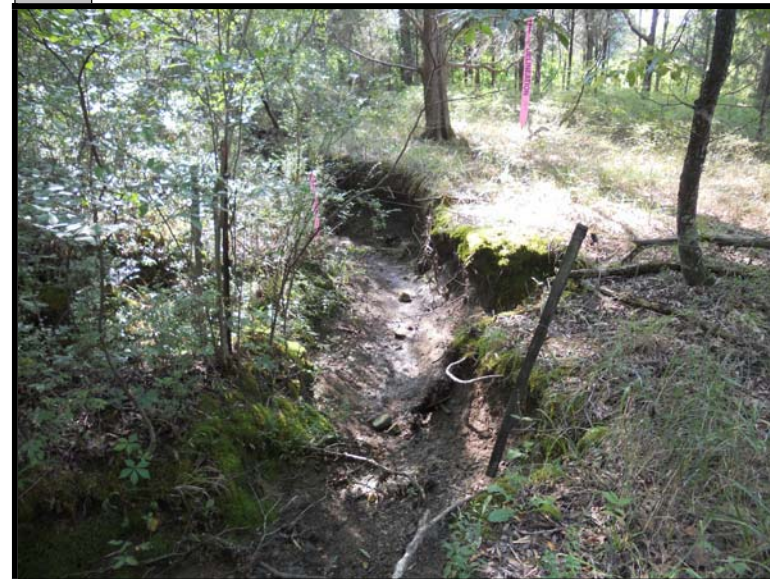
8 Stream 2 (S-RPW) on northern portion of site.

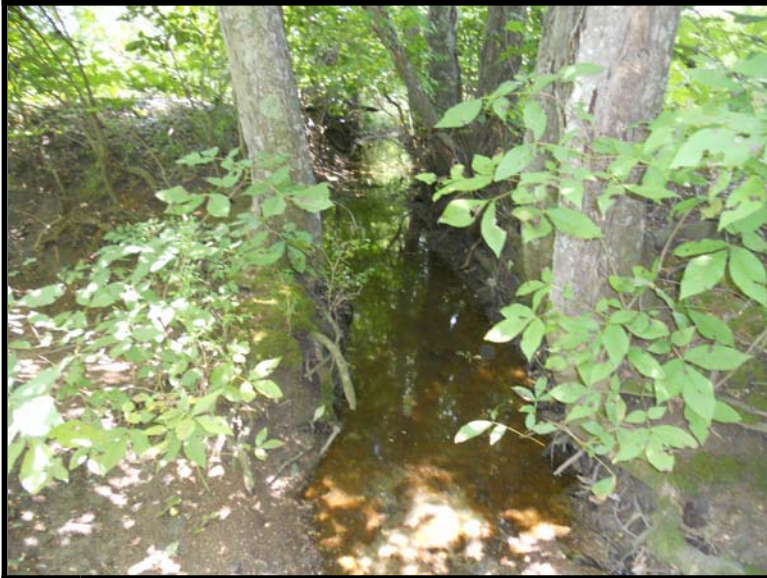
9 Stream 3 (S-RPW) on eastern portion of site. Stagnant pools with non-flowing water were observed during site visit.

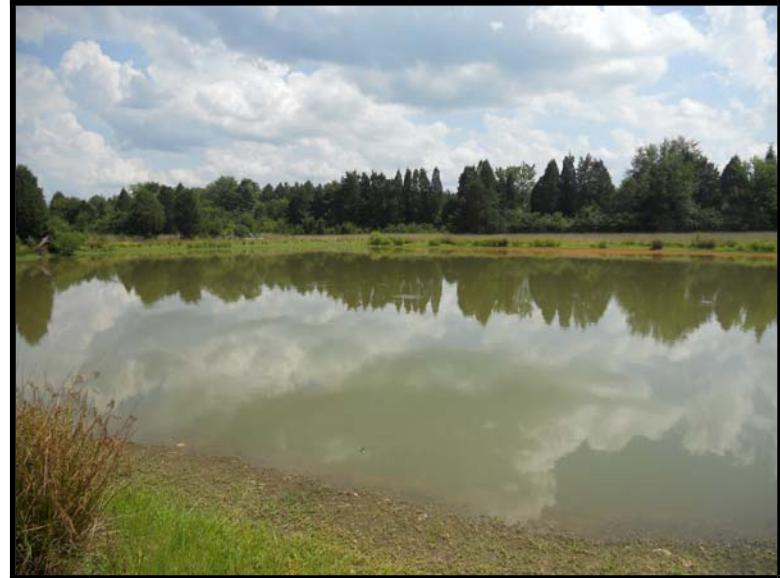
10 Upland-dug pond on southeastern portion of site. Pond does not have a hydrologic connection to other jurisdictional waters.

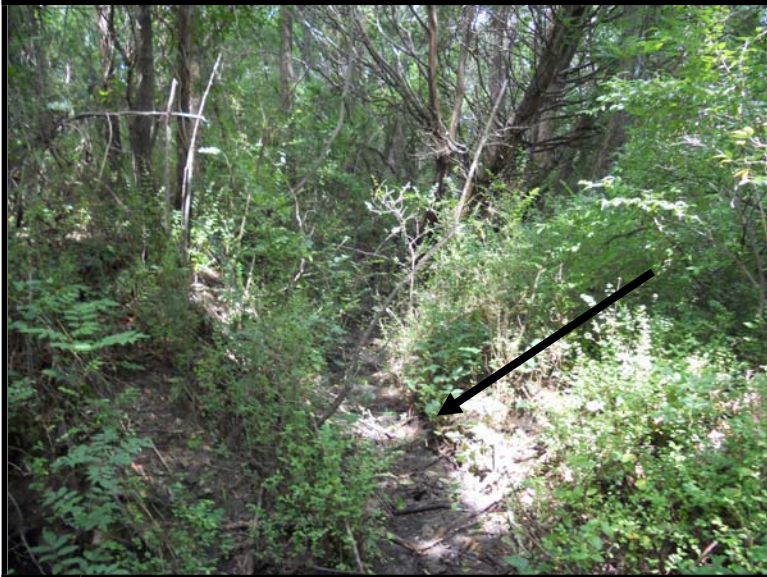
Six ephemeral/Non-RPW drainage features were observed on the site. These features lacked flow, and in most locations, lacked ordinary high water marks (OHWM) as well as bed and bank channel features.

11 Non-RPW 1 on northern portion of site.

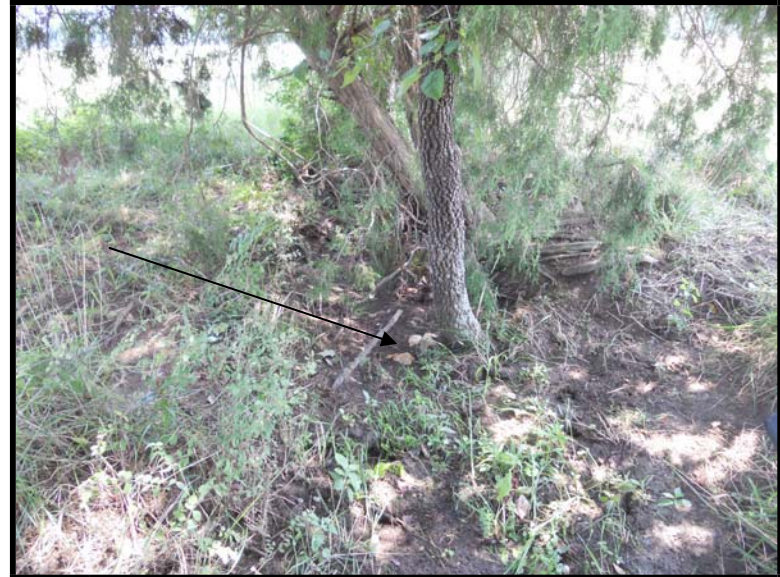
12 Non-RPW 2 on eastern portion of site.

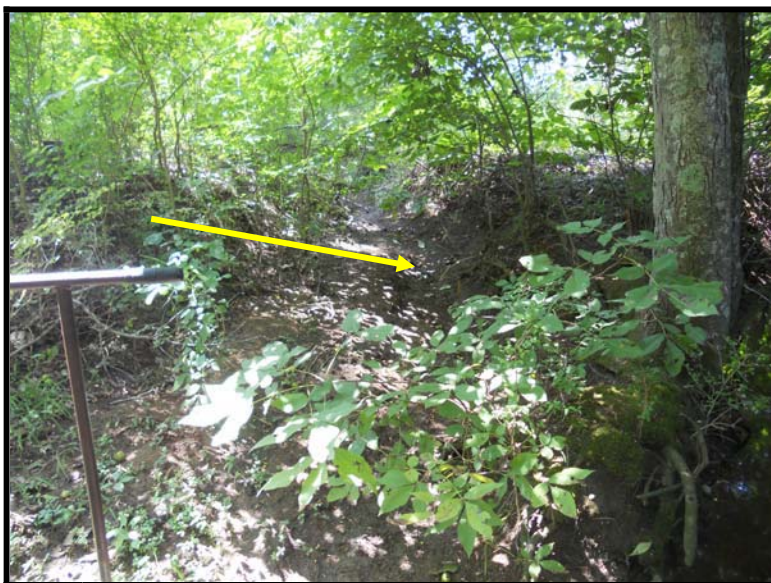
13 Non-RPW 3 on southeastern portion of site.

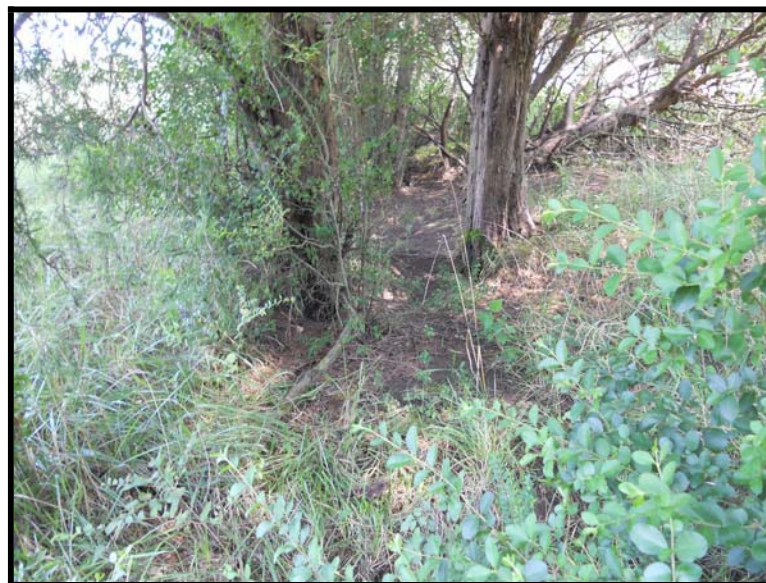
14 Non-RPW 4 on southeastern portion of site.

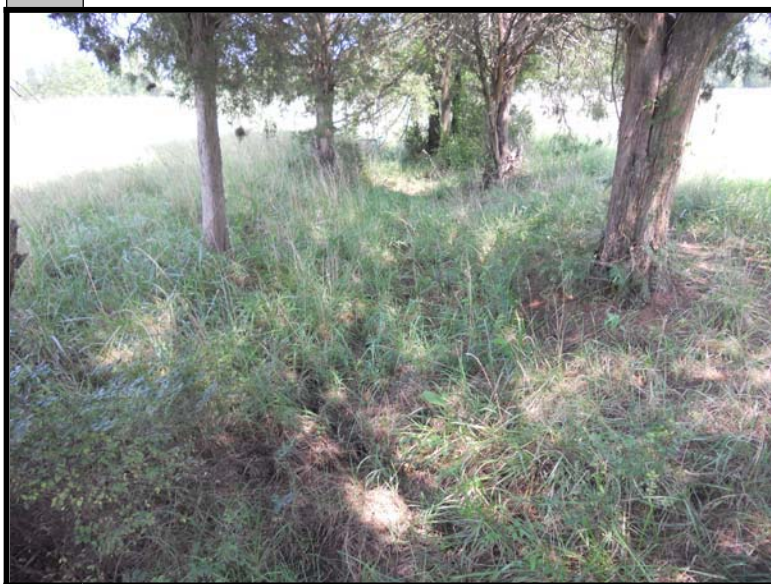
15 Non-RPW 5 on southeastern portion of site. Photo taken facing east just below upland-dug pond.

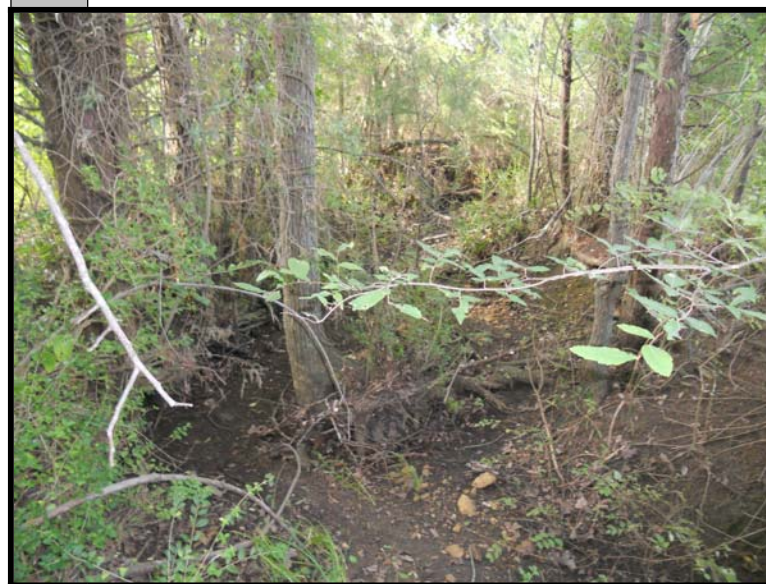
16 Non-RPW 6 on northern portion of site.

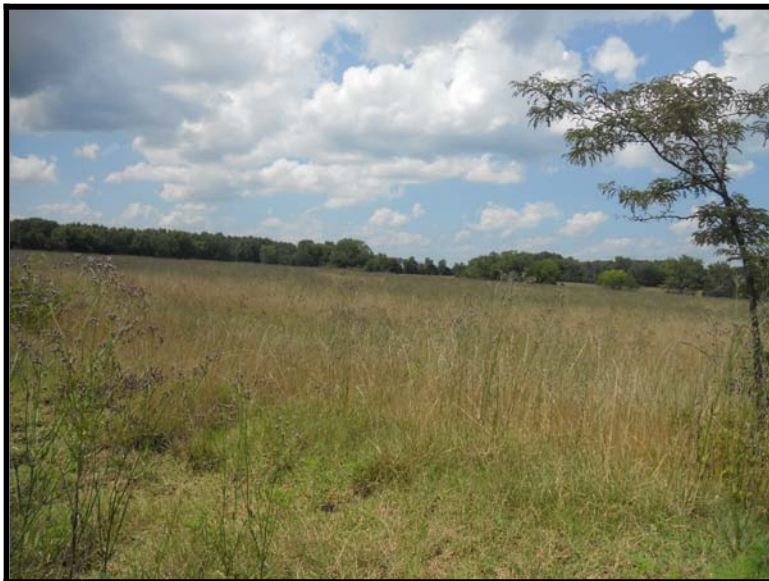
Upland areas (Photographs 17-20) on the site are predominantly open fields and mixed hardwood forestland. Vegetation was dominated by upland species and no evidence of hydrology was observed. The upland areas of the site consist of non-hydric soil series such as Iredell and Wilkes listed in the USDS-NRCS Web Soil Survey (Figure 4 – Soils Map). These areas are considered upland as all three wetland criteria (wetland vegetation, soils, or hydrology) were not observed.

17 Typical open field on site.

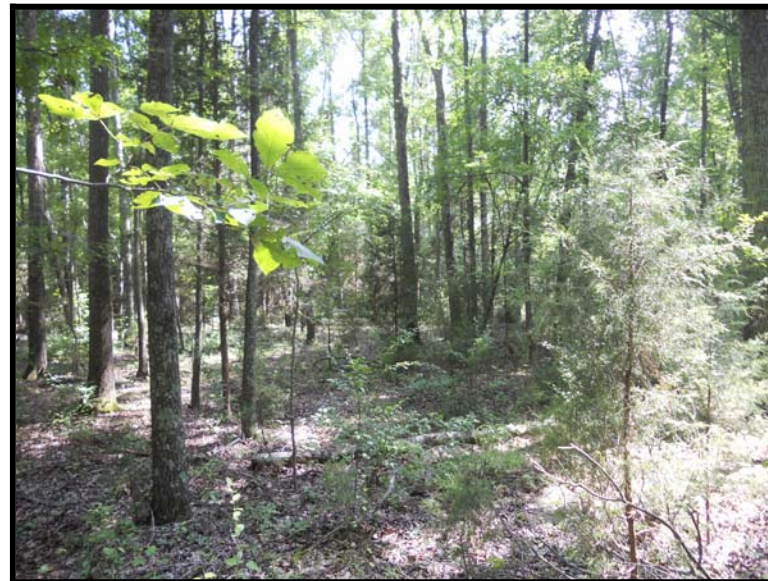
18 Typical mixed hardwood forestland on northern portion of site.

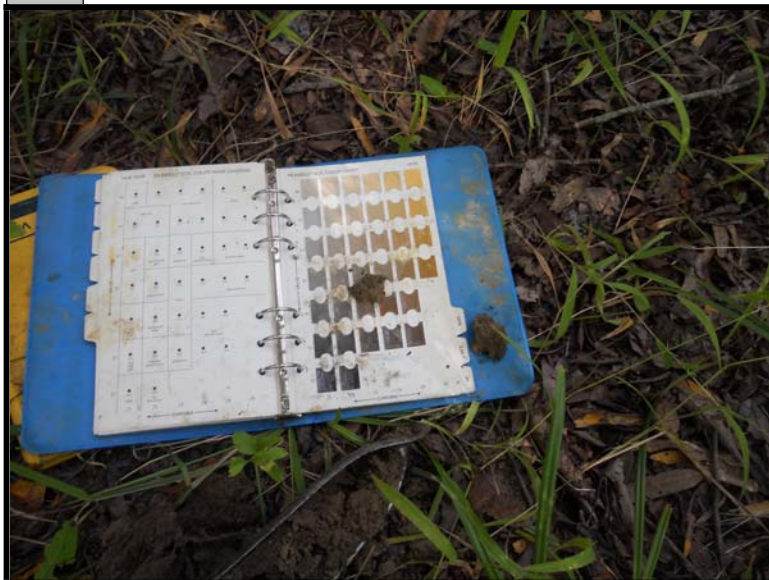
19 Upland soils adjacent to Wetland A (10YR 4/3).

Depth	Horizon	Matrix Color	Mottle Color	Mottle Abundance	Texture
1-16"	A	10 YR 4/4			Sandy loam

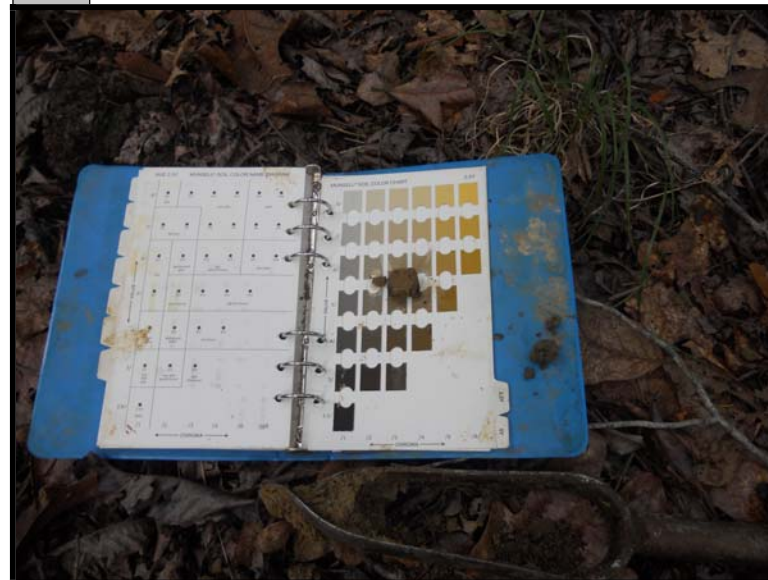
20 Upland soils adjacent to Wetland B (10YR 5/3).

Depth	Horizon	Matrix Color	Mottle Color	Mottle Abundance	Texture
1-16"	A	10 YR 5/3			Loamy clay
