JURISDICTIONAL DETERMINATION REQUEST

Project Name: Midlands Technical College Enterprise Campus Date: 25 September 2012

WETLAND DETERMINATION DATA FORM – Atlantic and Gulf Coastal Plain Region

WETLAND APPROXIMATION

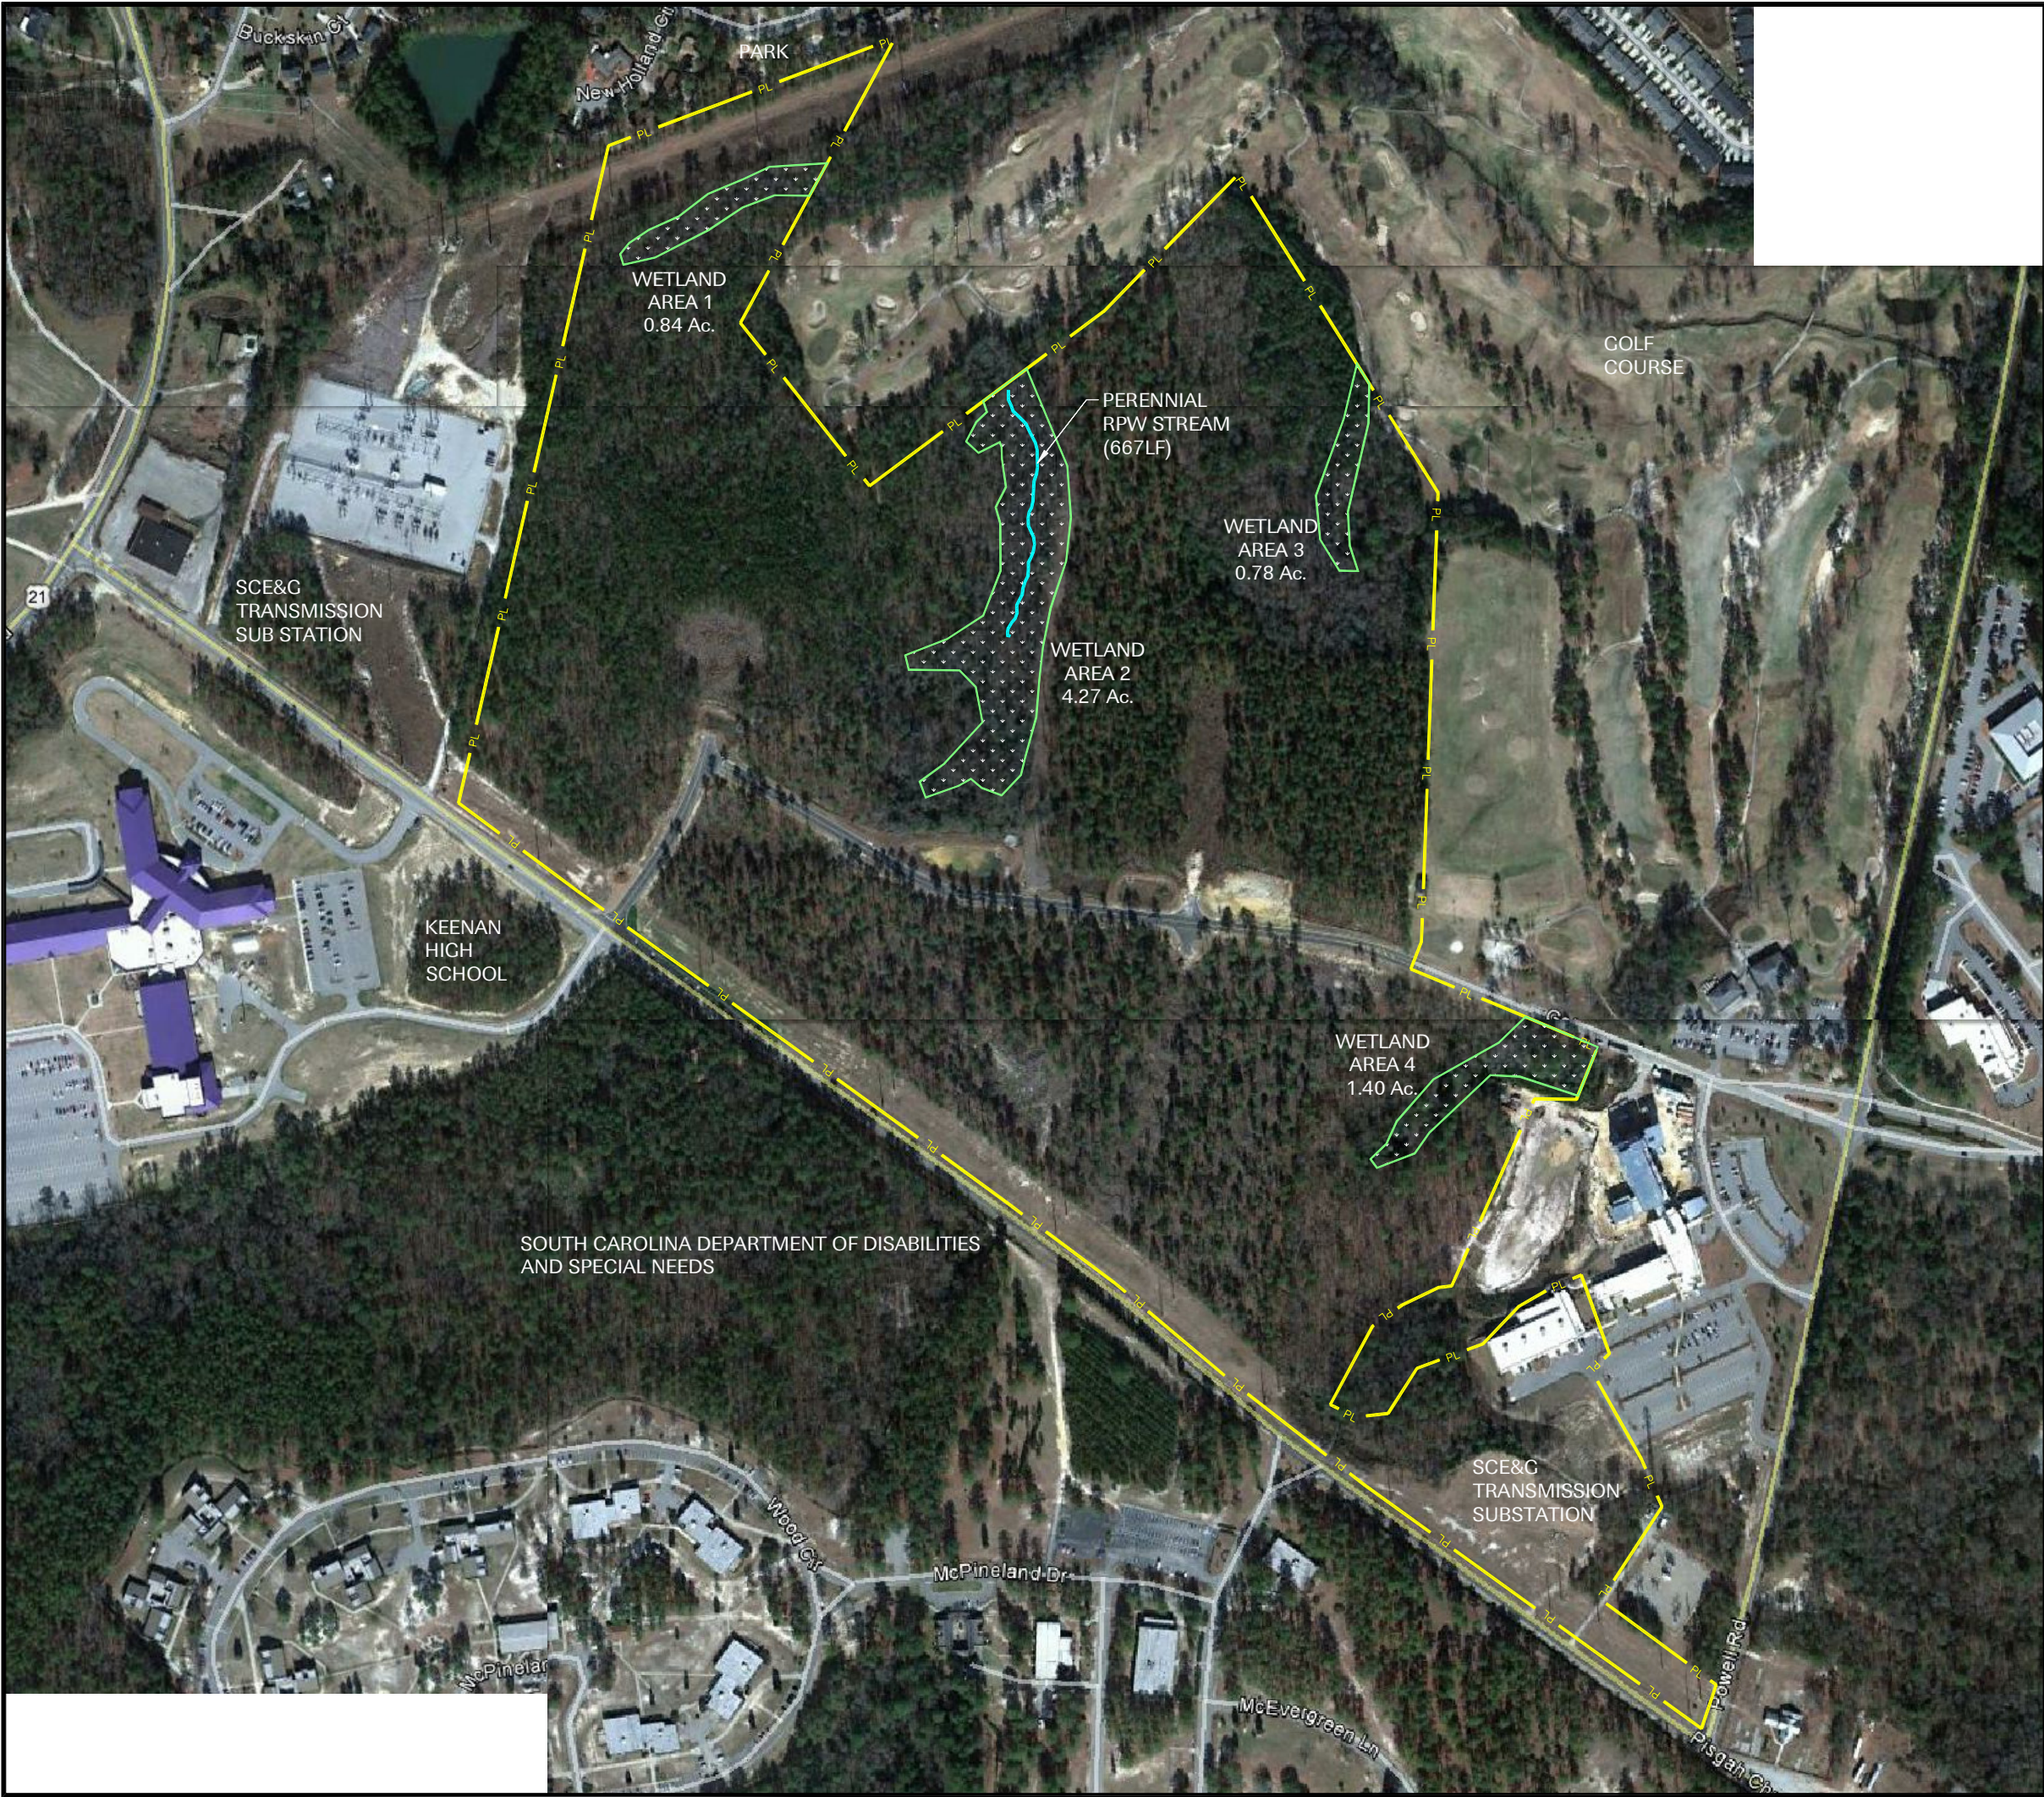
TOTAL SITE AREA = 130ACRES
WETLAND AREA 1 = 0.84ACRE
WETLAND AREA 2 = 4.27ACRES
WETLAND AREA 3 = 0.78ACRE
WETLAND AREA 4 = 1.40ACRE
TOTAL WETLAND AREA = 7.29ACRES

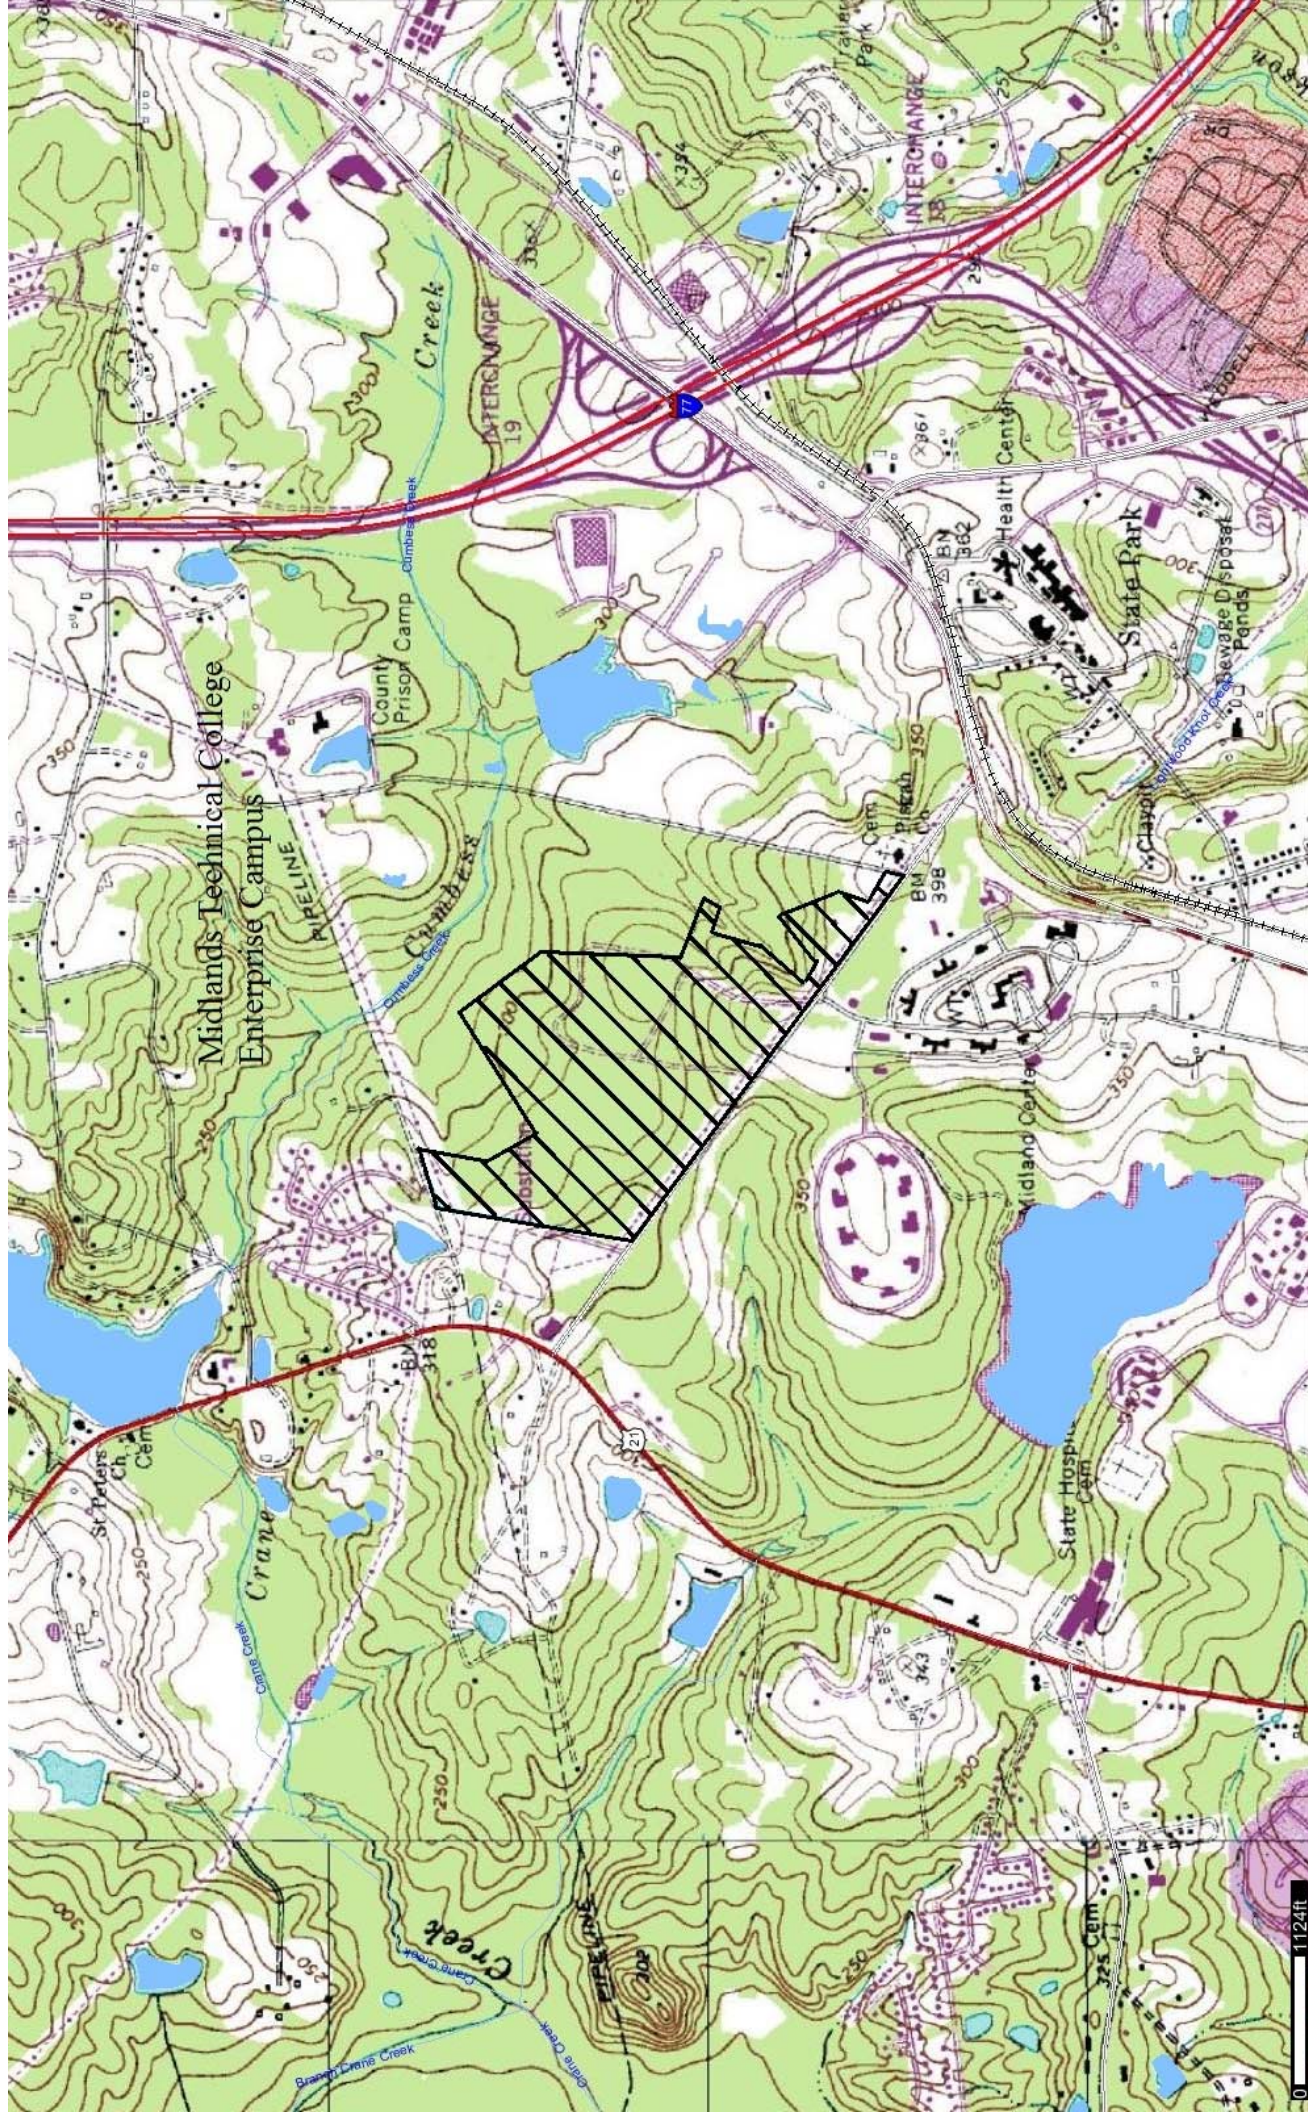
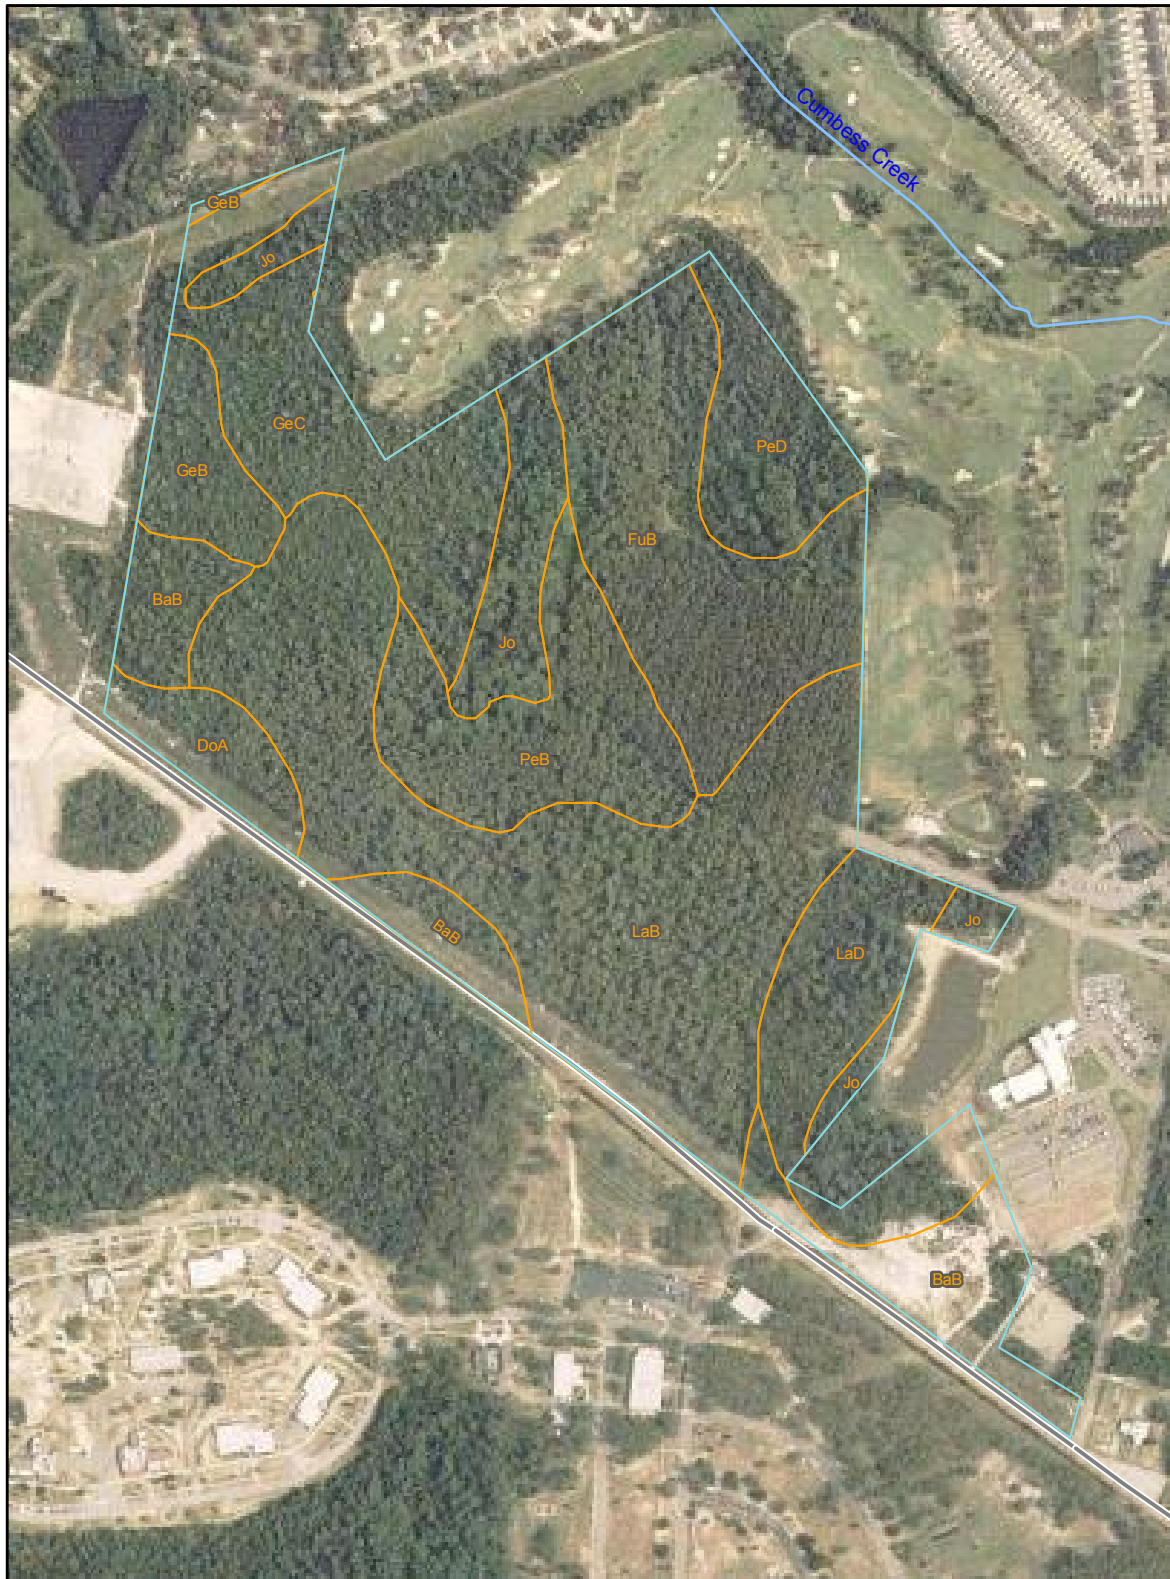
Soil Map—Richland County, South Carolina
(Midlands Technical College Enterprise Campus)

Warning: Soil Map may not be valid at this scale.
Enlargement of maps beyond the scale of mapping can cause misunderstanding of the detail of mapping and accuracy of soil line placement. The maps do not show the small areas of contrasting soils that could have been shown at a more detailed scale.

Richland County, South Carolina (SC079)			
Map Unit Symbol	Map Unit Name	Acres in AOI	Percent of AOI
BaB	Blanton sand, 0 to 6 percent slopes	12.4	9.5%
DoA	Dothan loamy sand, 0 to 2 percent slopes	4.0	3.1%
FuB	Fuquay sand, 2 to 6 percent slopes	19.4	14.9%
GeB	Georgeville silt loam, 2 to 6 percent slopes	4.7	3.6%
GeC	Georgeville silt loam, 6 to 10 percent slopes	14.8	11.4%
Jo	Johnston loam	8.1	6.2%
LaB	Lakeland sand, 2 to 6 percent slopes	37.4	28.8%
LaD	Lakeland sand, 10 to 15 percent slopes	10.5	8.1%
PeB	Pelion loamy sand, 2 to 6 percent slopes	11.9	9.2%
PeD	Pelion loamy sand, 6 to 15 percent slopes	6.8	5.2%
Totals for Area of Interest		130.0	100.0%
